## Inspection Report

**Report No.:** XYS-130914  
**Supplier :** XY-GLOBAL

**Inspection Date:** 11<sup>th</sup> Oct, 2013  
**Inspector:** Leo

| Inspection only for:<br>PO . XYS-130920 Item No.3567200 | <b>Inspection Result:</b><br>PASS |

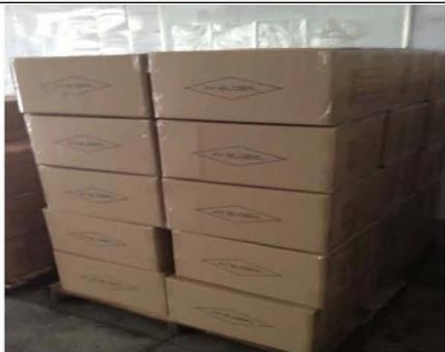
| 1. Packing | 2. Product |

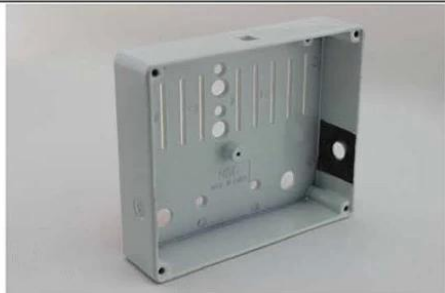
| 3. Product | 4 Product |

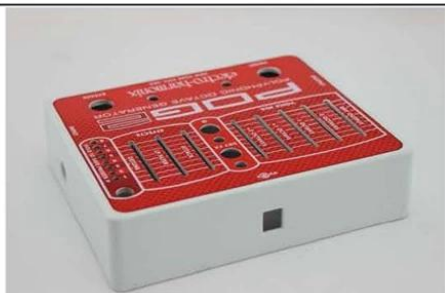
| 5. Product: | 6. Product: |
