## Inspection Report

**Report No.:** XYS-130727  
**Supplier :** XY-GLOBAL

| Inspection only for:<br>PO . XYS-130727    Item No.XY-1832500 | <u>Inspection Result:</u><br>PASS |

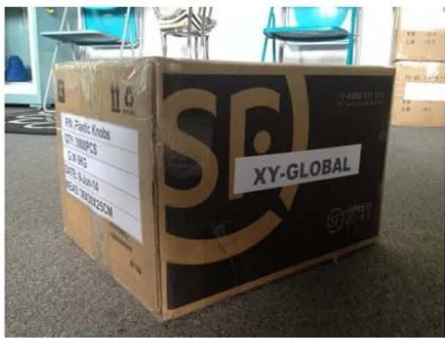
| 1. Packing | 2. Product |

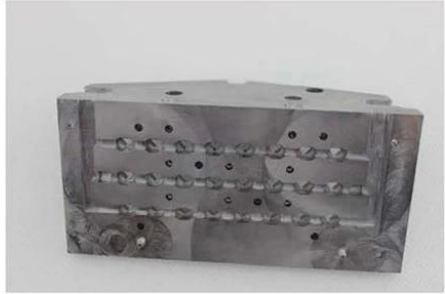
| 3. Product | 4 Product |

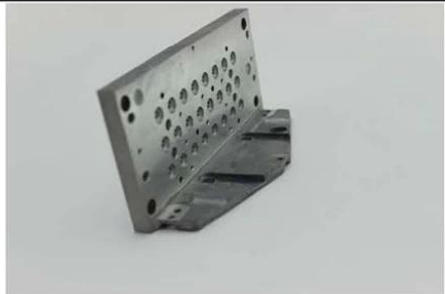
| 5. Product: | 6. Product: |
