## Inspection Report

**Report No.:** XYS-130514  
**Supplier :** XY-GLOBAL

**Inspection Date:** 04<sup>th</sup> Jun, 2013  
**Inspector:** Leo

| Inspection only for:<br>PO . XYS-130514 Item No.XY-1300291 | <u>Inspection Result:</u><br>PASS |

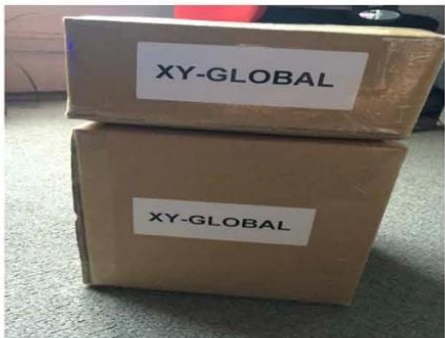
| 1. Packing | 2. Product |

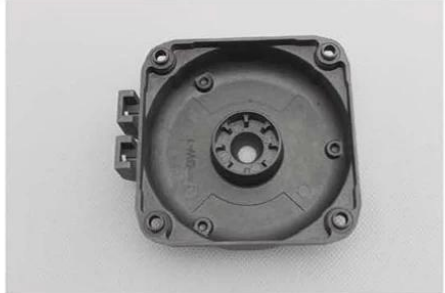
| 3. Product | 4 Product |

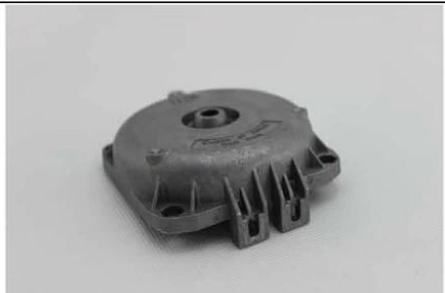
| 5. Product: | 6. Product: |
