## Inspection Report

**Report No.:** XYS-130928  
**Supplier :** XY-GLOBAL

**Inspection Date:** 25<sup>th</sup> Oct, 2013  
**Inspector:** Leo

| Inspection only for:<br>PO . XYS-130920 Item No.3240100 | <u>Inspection Result:</u><br>PASS |

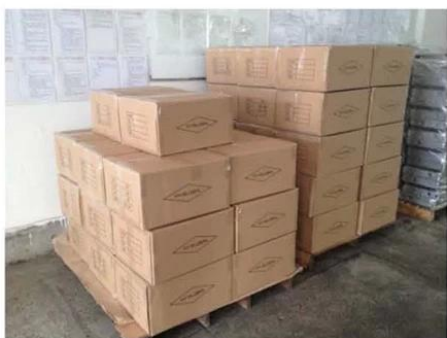
| 1. Packing | 2. Product |

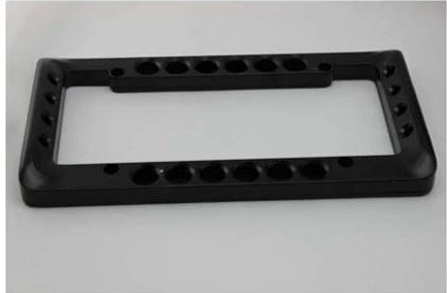
| 3. Product | 4 Product |

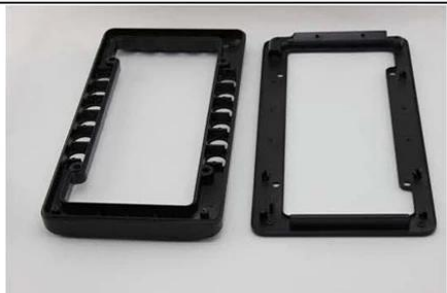
| 5. Product: | 6. Product: |
